HIGHWAY RESEARCH REPORT

EXPERIMENTAL ASPHALT TEST SECTIONS ON THE NEWCASTLE AND COLFAX JOBS

FINAL REPORT

NO. M & R 643230

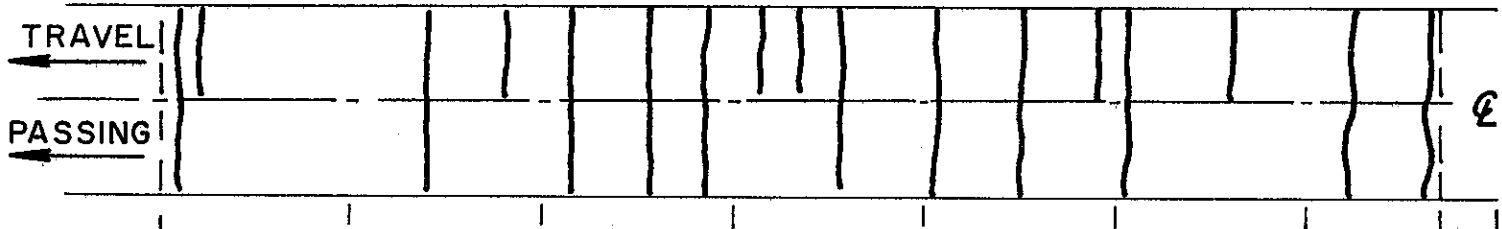
Figure 1

CRACKING PATTERN FOR SECTION A
CONT. 57-3TC27, ROAD 03-PLA-17,37-B,AUB.
NEWCASTLE JOB

THE PATTERN IS TYPICAL FOR
THE OTHER FOUR TEST SECTIONS

MAY, 1960 AGE=24 MONTHS

MAY, 1962 AGE = 48 MONTHS

JAN. 1967 AGE = 104 MONTHS

The cracking pattern of all five test sections on the Newcastle job has been similar during service life. The typical cracking pattern for all sections is shown in Fig. 1. Fatigue cracking has not been a problem on this job, and the initial transverse cracking may be assigned to reflection cracking from the cement treated base. As shown in Table A the first longitudinal cracking occurred during the 24-48 month period and continued to increase thereafter. The increase in total cracking, (transverse and longitudinal) during service life for the Newcastle test sections is shown in Fig. 2. There is a definite difference in the amount of cracking, Sections C and E, the "No Dust" and 2.0% Limestone Sections being much lower than the Standard Paving Mixture used in Sections A and B. The rate of increase in total cracking is very interesting. There is a rapid increase in transverse cracking up to 12 months and virtually no increase up to 24 months. This is all transverse cracking since no longitudinal cracking was observed during the first 24 months of service life. One may conclude, based on the very low deflection results during this period, that the transverse cracking was of the reflection type and gradually came to virtually a halt during the 12-24 month period. However, thereafter, in the 24-48 month period the transverse cracking again increased at a rapid rate as shown in Fig. 3. This increase coupled with the start of longitudinal cracking increased the rate of total cracking to a high figure. Again in the 48-104 month periods the total cracking although increasing definitely slowed in comparison to the previous period.

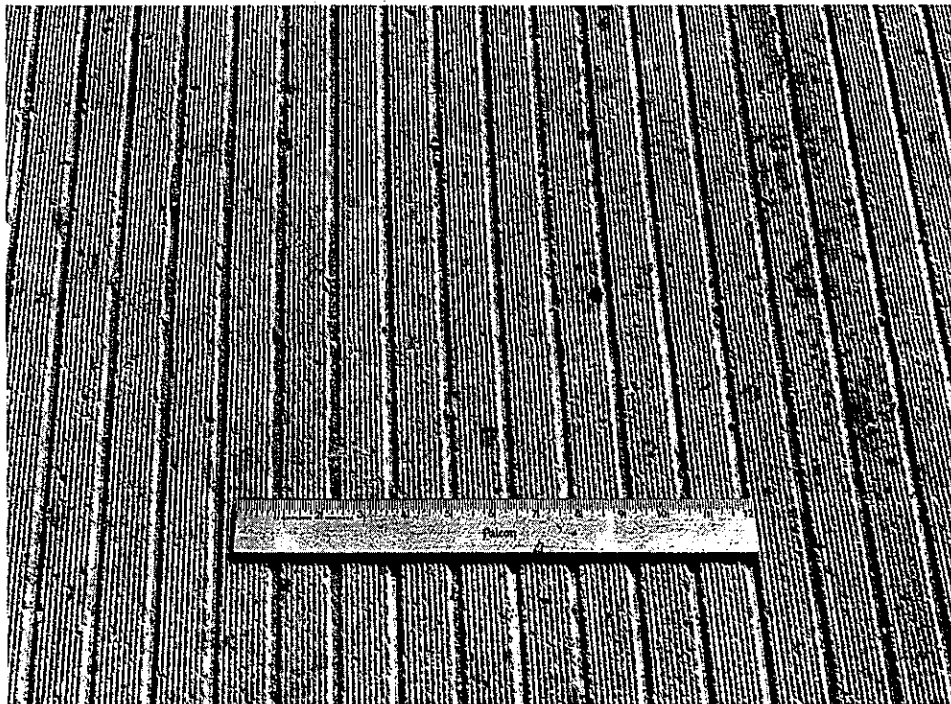
Figure 2

Photographs of Several Patterns Used on Various Projects

Rectangular Grooves

Style 15

A number of patterns have been used in our serration work to date. This was done in order to determine the increase in the friction factor, wear resistance, and possible vehicle handling problem. In all cases the grooves are all in a longitudinal direction. Figure 3 shows the patterns used on the various projects, and Table A the increase in the friction value after grooving and the change during service life. Figure 4 shows the effect of grooving on the average coefficient of friction value for the various PCC pavement projects.
